Inspection Report Minerals Regulatory Program Report Date October 26, 2005

Mine Name: Cameron #1	Permit number: S/047/036
Operator Name: Asphalt Ridge, Inc.	Inspection Date: August 31, 2005

S/047/036, Cameron #1 Mine, Asphalt Ridge, Inc.

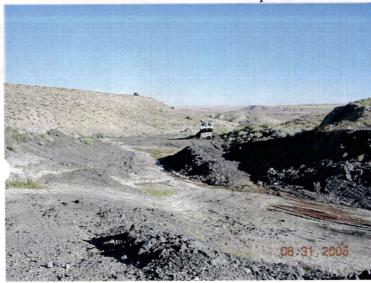
There are two main areas of the mine. The one to the southwest on the map is the pit, part of which is shown in Photos 1 and 2. The other part of the mine is an area that, as mentioned above, has been used for crushing, screening and mixing gravel and asphalt. Both of these areas are shown on a map in the notice. The stream runs between them.

Photo 1. This view is looking approximately southeast through the pit area.

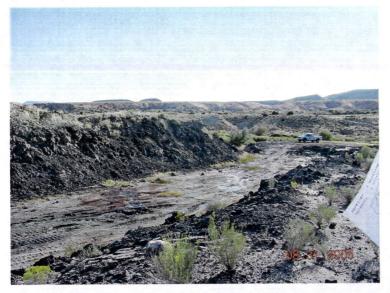
Photo 2. Another view of the pit taken from the bank next to the stream and looking approximately northwest.

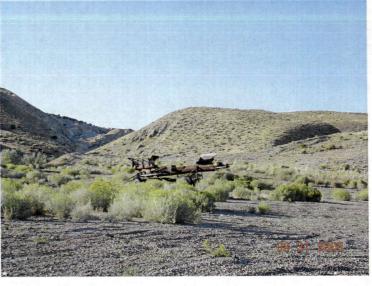
In an effort to increase the area that could be mined, the prospective new operator ripped and intends to seed an area that had been used for crushing, screening, and mixing gravel and asphalt. I photographed the area during my inspection (Photo 3). Photo 4 shows the reclamation work the prospective operator performed. This photo was received by e mail on October 26, 2005.

Photo 3. An area that has been used for crushing and mixing asphalt and gravel.

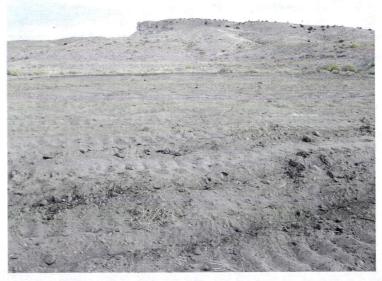
Photo 4. This photo was taken by the operator, and I received it October 26, 2005. It is the same general area as shown in Photo 4 and shows how the area was prepared for seeding.

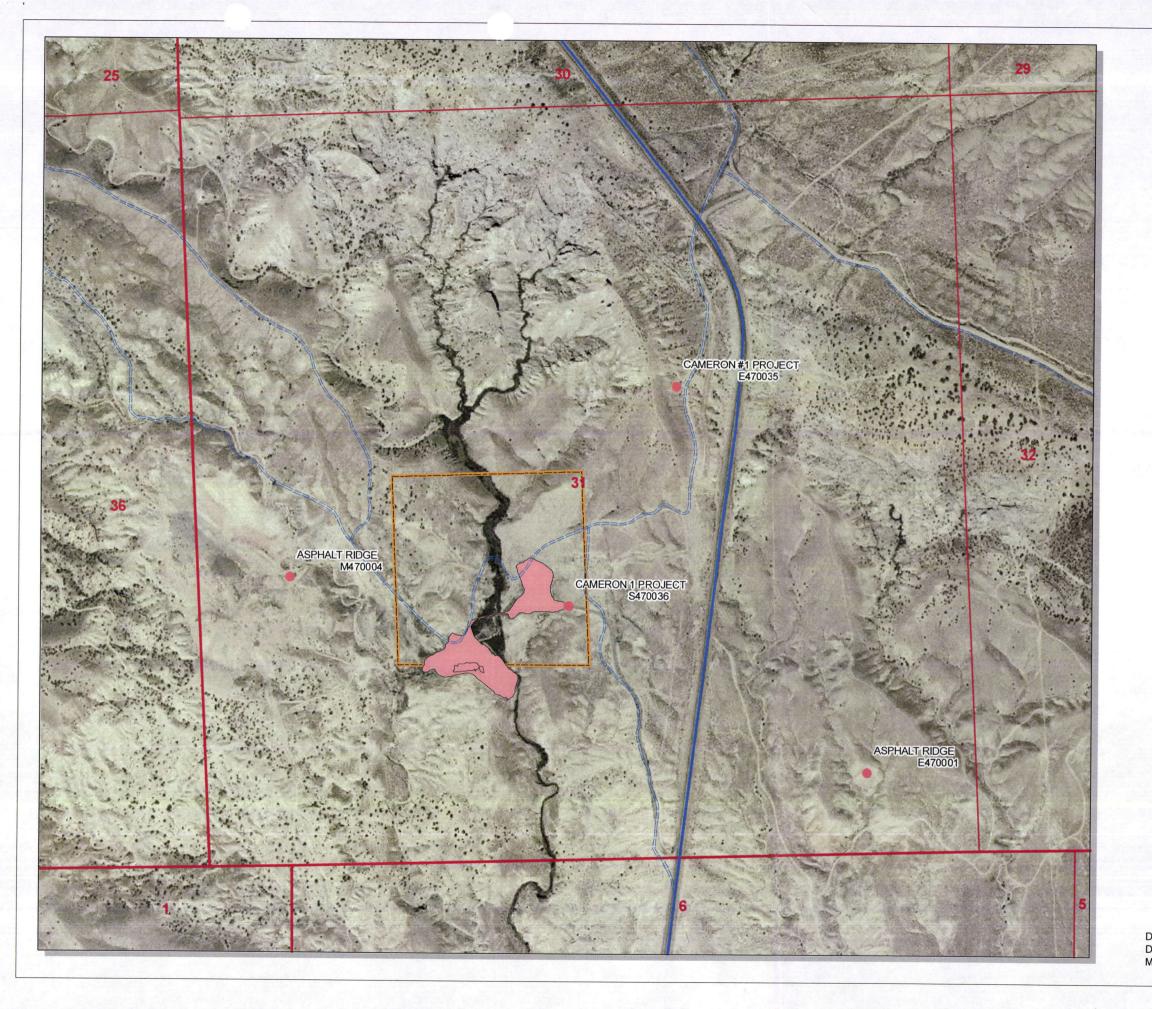
There has been a lot of mining and exploration activity in this area, and it is difficult to determine exactly what the current operator is responsible for. After the last inspection, I asked the operator to place stakes around the area he considers to be part of this operation. I was able to find several of the stakes but not all, so when I took GPS readings to create a map of the disturbed area, I probably included areas that are not permitted under this notice. The map shows the disturbed area being 5.4 acres, but this is probably not accurate.
